# TEST REPORT

Report No.:  
KR16-YYP0224

3. Name of Product and Model : Network Camera / XNV-8080R\*  
(\* N: NTSC / P: PAL)

6. Test method used : IEC 62262: 2002 (IK 10)

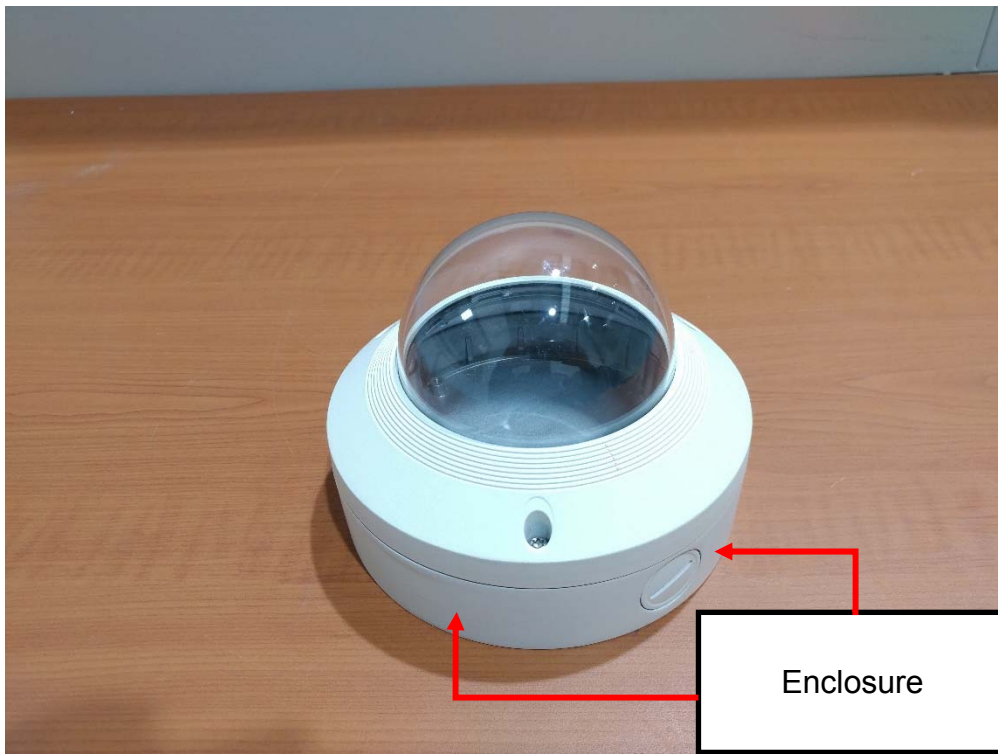
[Impact Zones 1]

- 1) Reference Documents: IEC 62262: 2002 (IK 10)
- 2) Energy: 20 Joule
- 3) Mass: 5.0 kg
- 4) Height: 400 mm
- 5) Location and number of impact: Window 5 impact, Enclosure 5 impacts
- 6) Pretreatment: None

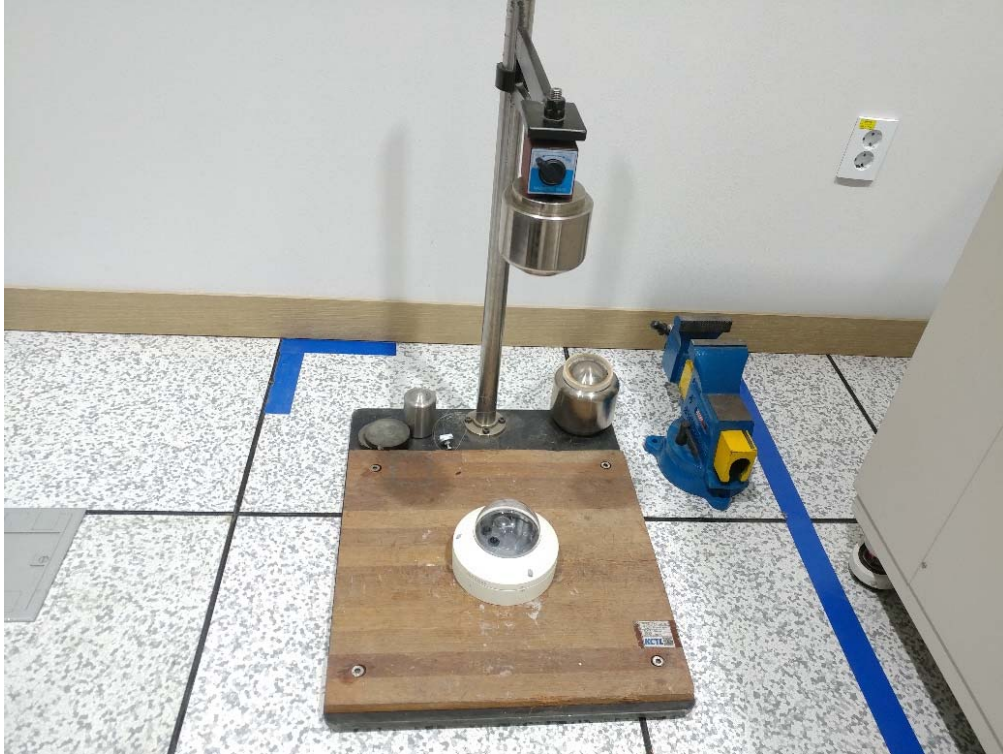
[During the test\_Window]

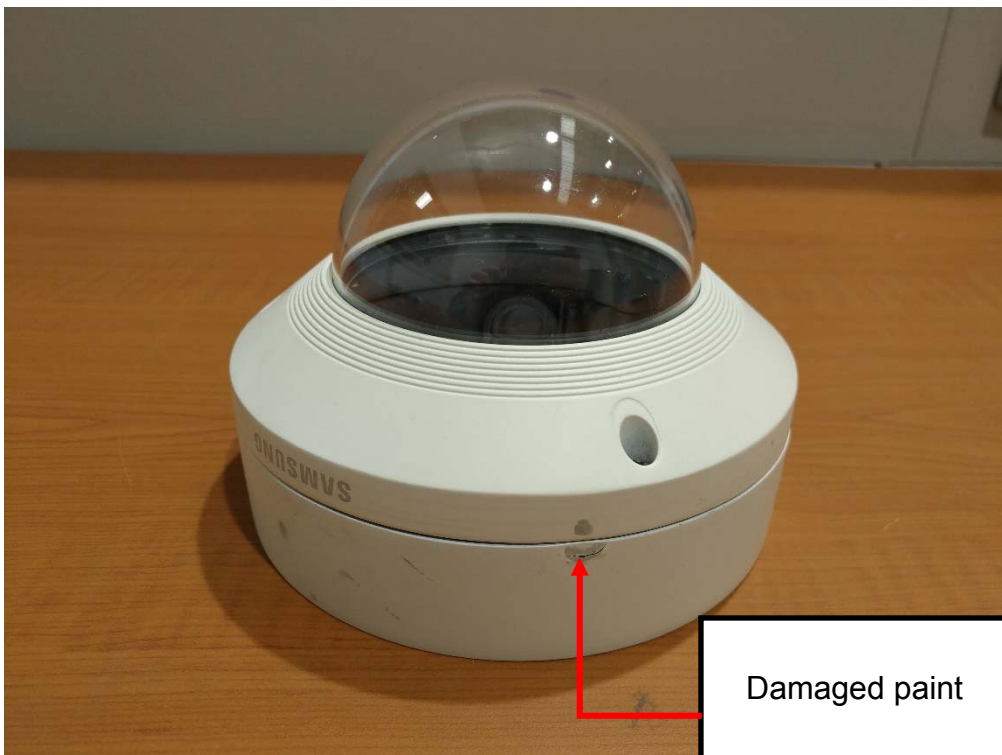
[Test result 1]

| Impact Zone: Window | | |
|---|---|---|
| Impact 1 | Normal to surface of window. | No abnormal was found<br>※ Refer to 3.1.9 |

| Impact Zone: Enclosure | | |
|---|---|---|
| Impact 1 | Normal to surface of enclosure. | No abnormal was found<br>※ Refer to 3.1.9 |

- 1) Visual inspection after impact test.
- 2) Check if Crack, separation occur.
